MOLD INSPECTION AND TESTING REPORT

**4886 Paseo de Vega
Irvine CA 92603**

Test Date:	April 30, 2021
Report Date	May 03, 2021

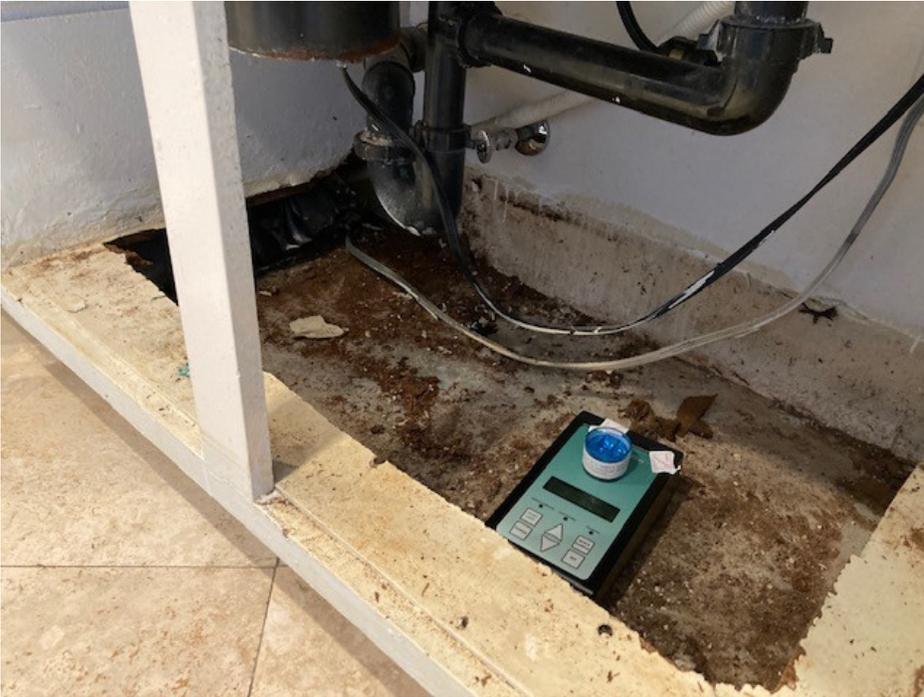
Figure 1 a non-viable air sample was taken underneath the kitchen sink . The air sample revealed toxic mold. (see findings and recommendations)

Based on the samples taken and the lab report from Hayes Laboratory there is a serious mold issue problem found from the Non-viable air samples taken in the kitchen. **Stachybotrys** and **Chaetomium** known as toxic mold had high levels. The non-viable air sample taken in the upstairs bathroom also had a **toxic mold, Penicillium/Aspergillus**. The swab sample taken from the crack in the bathroom shower was covered with moderate amount of **Chaetomium**.

- Set up full containment in kitchen
- Remove kitchen sink cabinet and Dishwasher
- Remove drywall behind sink from floor up 4' and 18" beyond water intrusion

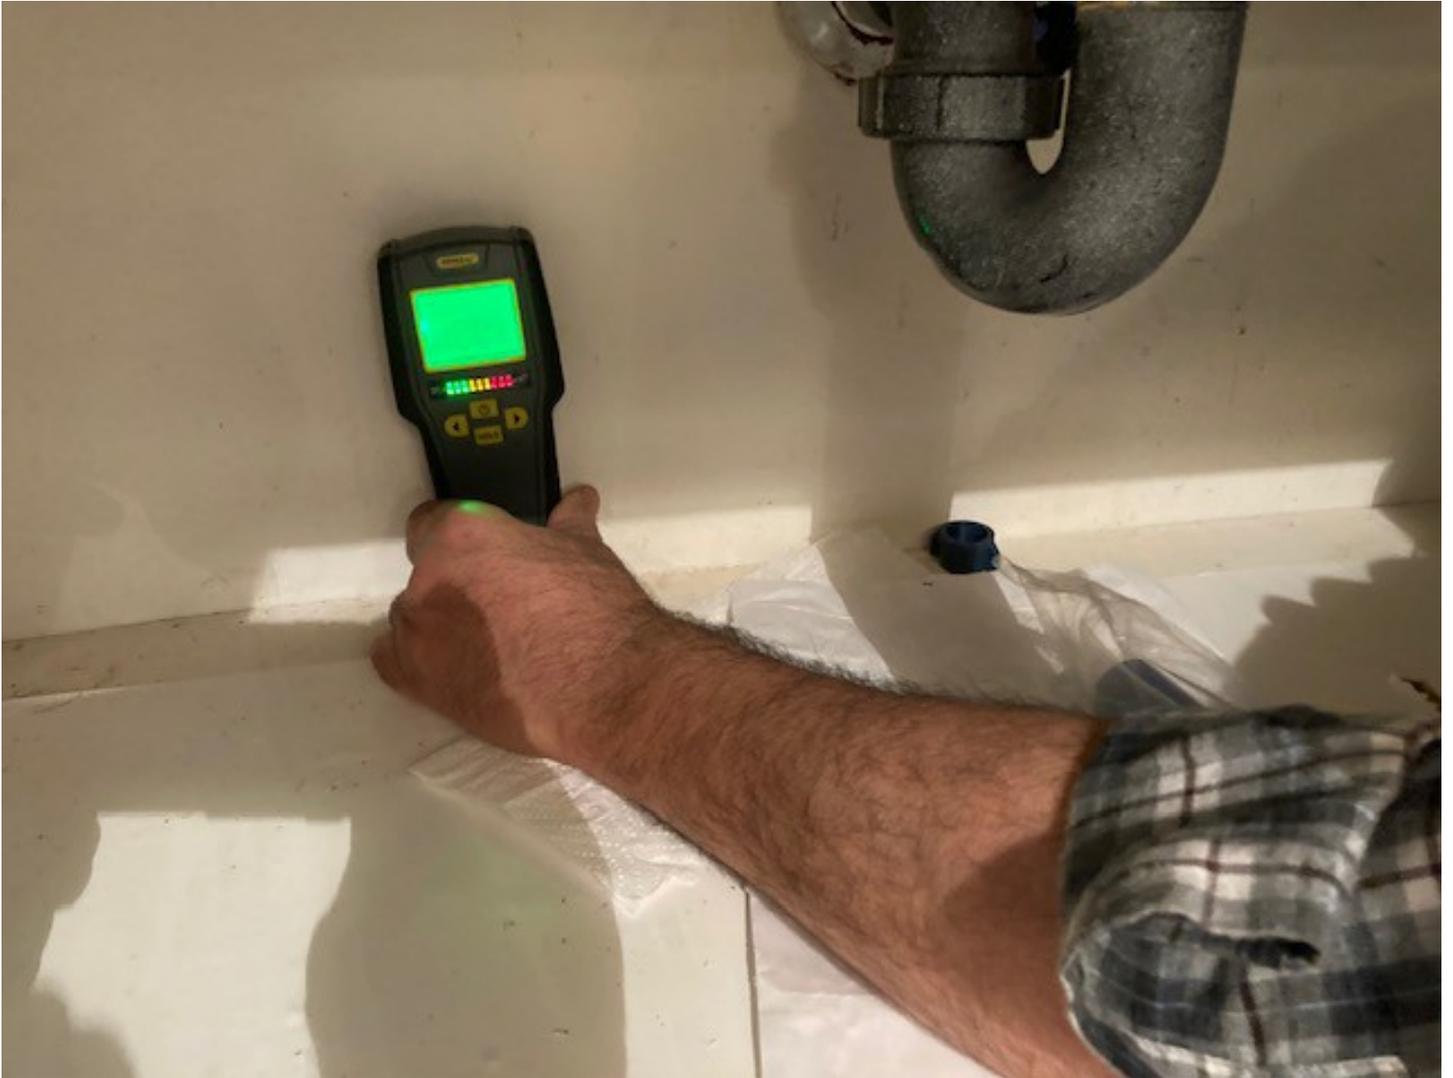
Figure 2 A moisture meter shows over 100% moisture (Red) behind the drywall underneath the Master Bathroom

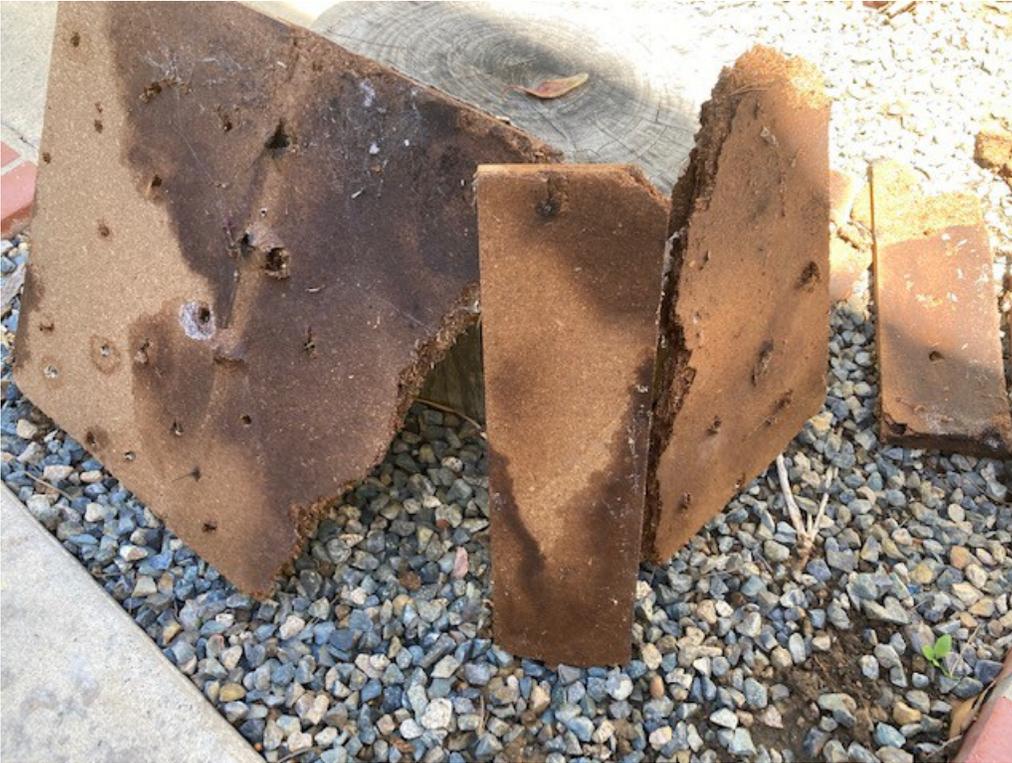
Figure 3 Here is the remains of the fiber board that was removed under the kitchen sink

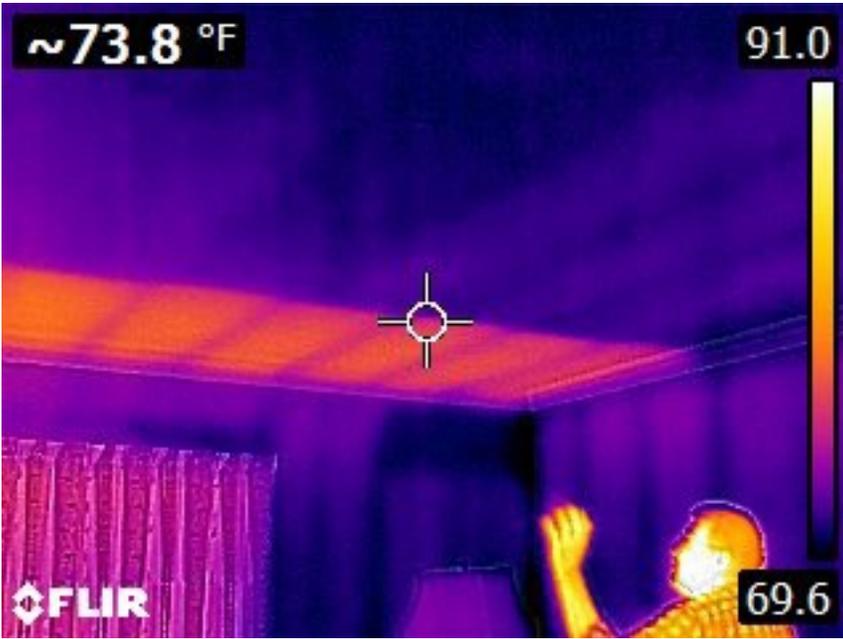
Figure 4 Thermo Image ceiling below bathroom Dark purple detects moisture

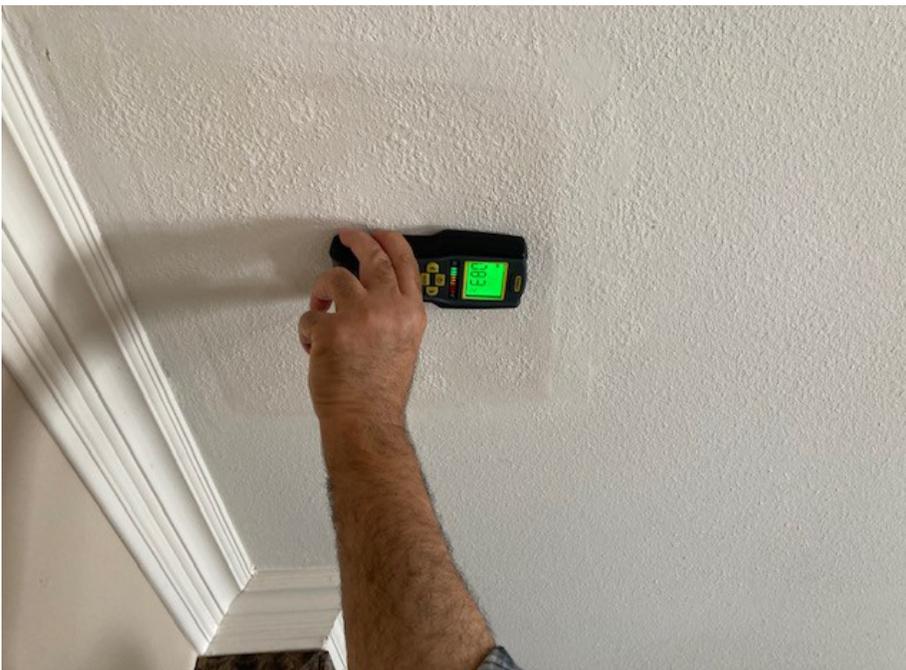
Figure 5 Just below toilet moisture from possible wax seal leaking

- Set up containment in Upstairs bath
- Remove bathroom sink from wall
- Remove drywall from floor up 4' and 18" beyond water damage
- Remove toilet (later replace wax seal)
- Remove fiberglass shower
- We provide any build back of any moldy building that are removed and discarded if necessary during the process. I.E.C. expertise is to kill, remove, and prevent mold growth from coming back with our 10 years' work guarantee with post clearance certification. I.E.C. also formally submitting herein a mold remediation bid quotation to conduct the mold remediation procedures.

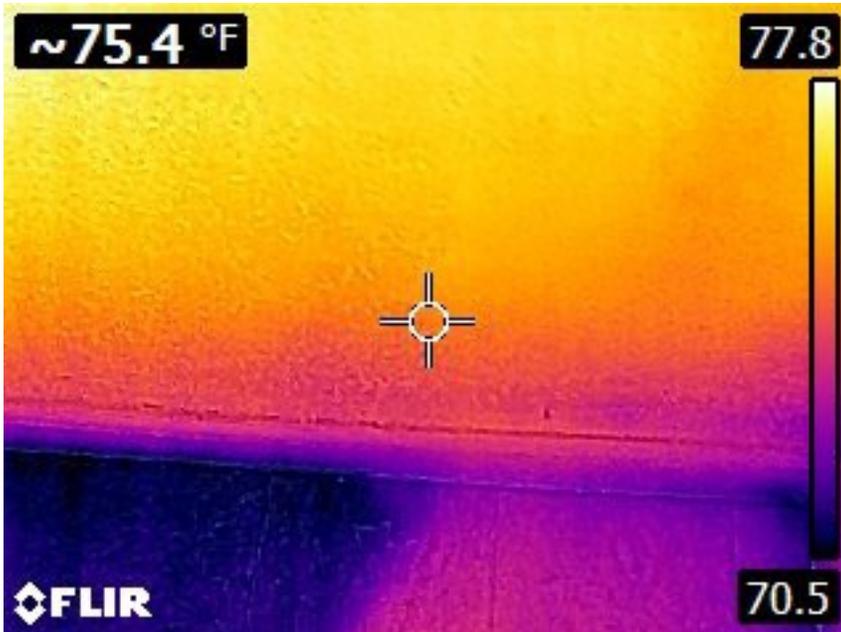
Figure 6 Here upstairs in bathroom cabinet the drywall was moist and damp

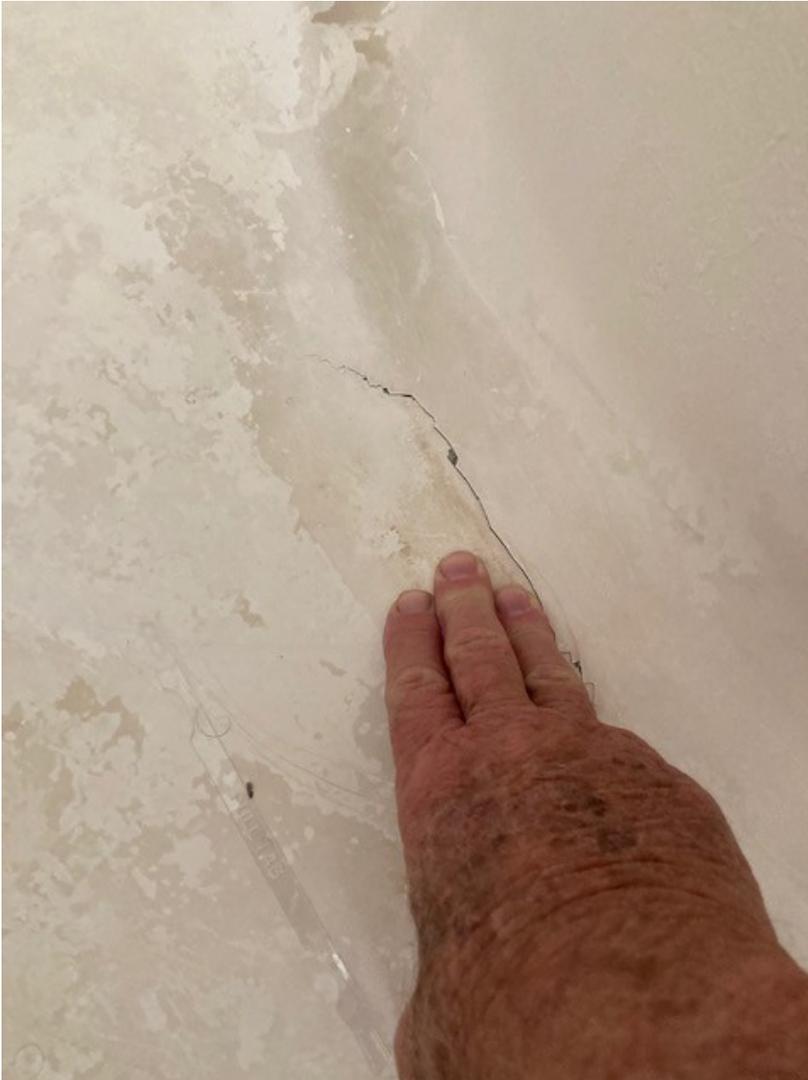
Figure 7 Upstairs shower fiberglass floor cracked water when showering has been leaking to ceiling in front room
